**Carnarvon One Mile Jetty  
Damage Assessment Post Cyclone Seroja  
21<sup>st</sup> & 22<sup>nd</sup> April 2021**

**Department of Transport**

Report 2021/0401

28<sup>th</sup> April 2021

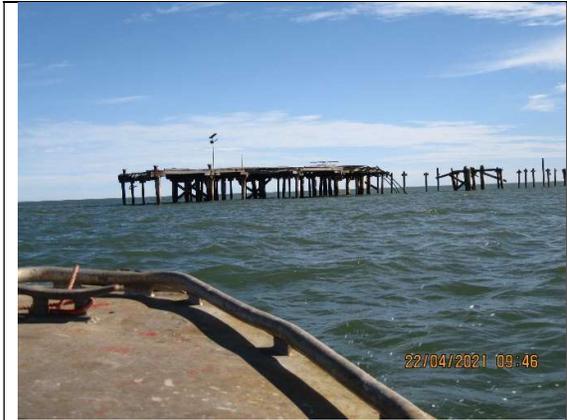
The jetty head was essentially destroyed with 5 bays (Piers 239 to 245) still standing at the very end and a further two bays still standing further east. It is worth noting that in sections totally destroyed only steel piles remain. Inspection of the few pile sections washed ashore or retrieved from the beach indicate that the timber piles snapped at the waterline. These piles showed evidence of excessive section loss due to a combination of rot and attack by marine organisms including Limnoria and possibly Teredo.

Photo 1 Jetty Head - 5 bays remaining.

It is recommended that the section of jetty between Pier 70 and Pier 245 (Jetty head) is demolished to prevent risks to safe navigation.

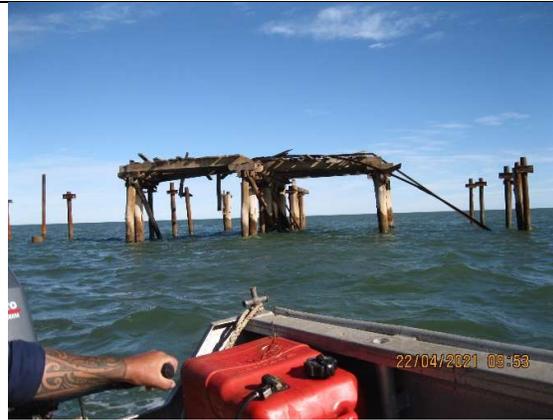
Photo 2: Portion of jetty head - note steel piles remaining.

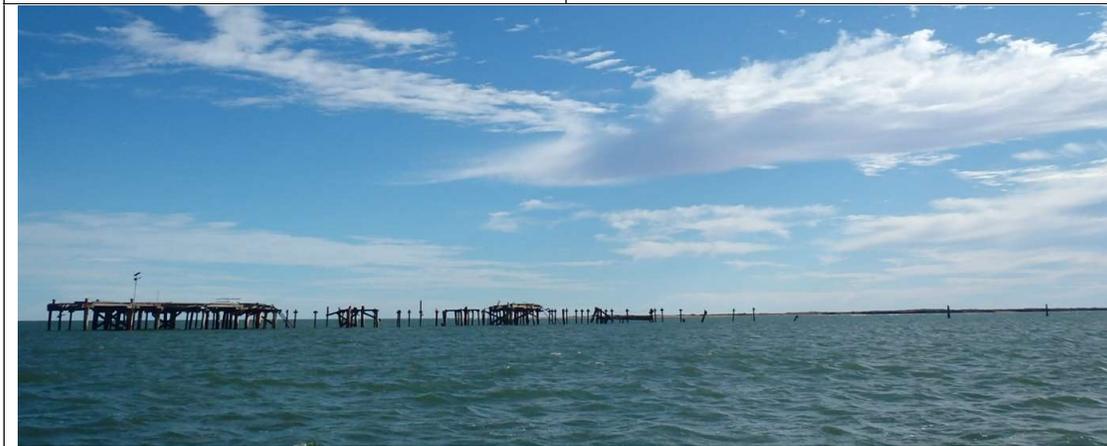
Photo 3: Panoramic view of jetty head and end of approach jetty showing missing sections

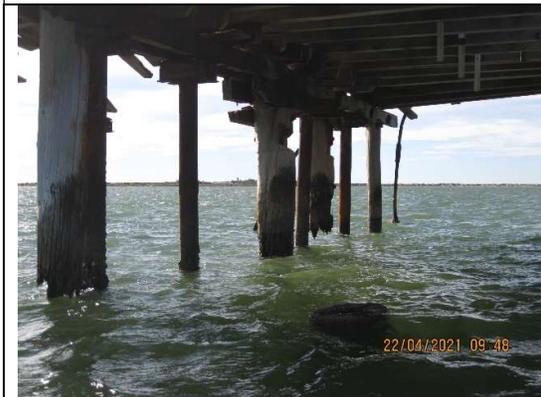
It is therefore likely that remaining piles are similarly affected and therefore unlikely to withstand another extreme event. Crossheads that were washed ashore or still in remaining in destroyed sections revealed that bolts securing the corbels were still in place and showing various degrees of corrosion. However, the splitting evidenced in the corbels (Refer Photo 24) would indicate that the corbels and stringers would have been separated from the crossheads due to the split timbers and not due to failure of corroded bolts.

Photo 4: Underside of jetty head showing timber piles completely rotted at water line

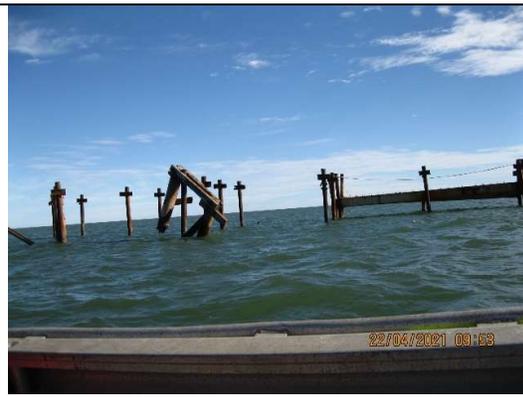
Photo 5: Broken Pier showing broken timber pile with crosshead still attached to steel pile

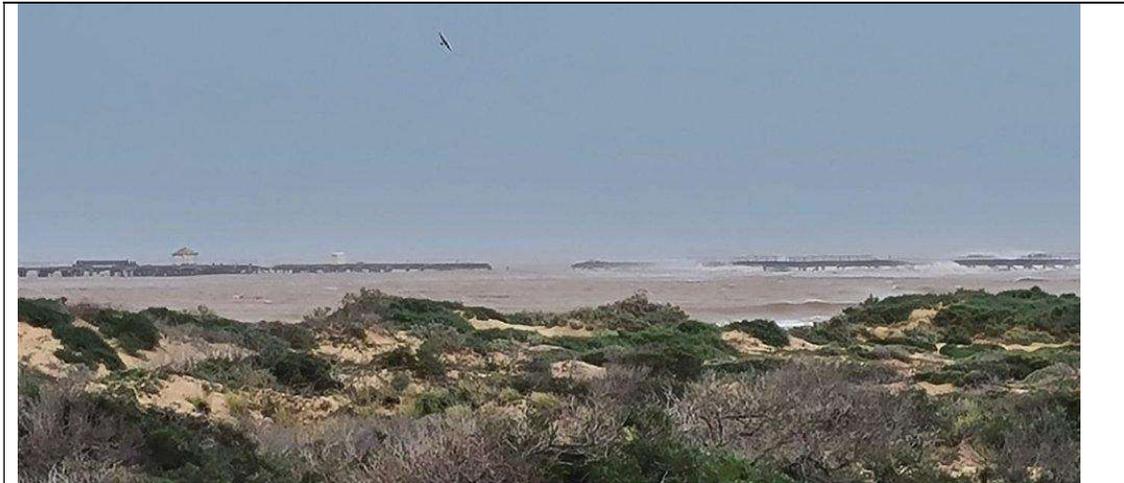
The section of the approach jetty between Piers 186 and 218 (approximately 190m) was effectively totally destroyed with only two small sections left standing see Photo 8 and Photo 9. This section of jetty is in an average depth of RL -2m CD. Given the tide and storm surge at the time (Refer Figure 2), the total still water level (SWL) would have been in the order of 4 to 4.5m CD in this location and therefore capable of sustaining a wave of up to 4m in height. The crest height of a breaking wave in this location could be as high as 5.4m (SWL +80% wave height). Photo 6 and Photo 7 taken by Eddie Smith (Carnarvon Shire) show waves breaking over the jetty at this location.

Photo 6: Photo taken during the storm - approx 10 AM - note waves breaking over approach jetty (Courtesy Eddie Smith)

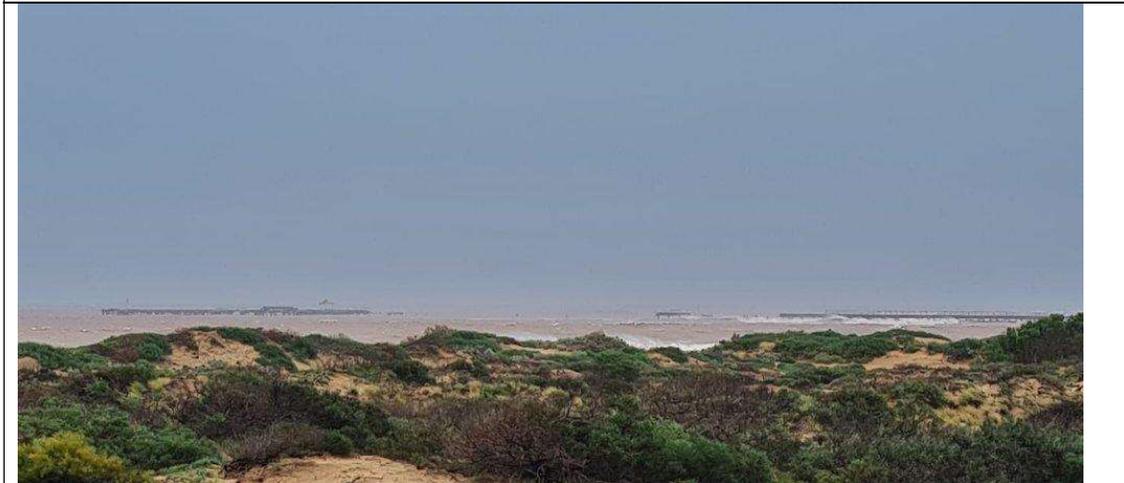
This section was spared to some degree as the approaching waves from the north were broken by the shallows at the mouth of the Gascoyne River. The broken waves can be seen in Photo 7. Damage was still evident in the form of snapped or missing piles, missing cross bracing, broken stringers and broken handrailing. Typical damage is shown in Photo 10 to Photo 15.

Photo 7: Photo taken short time later showing demolished section of the approach and breaking waves in shallow beach area (Courtesy Eddie Smith)

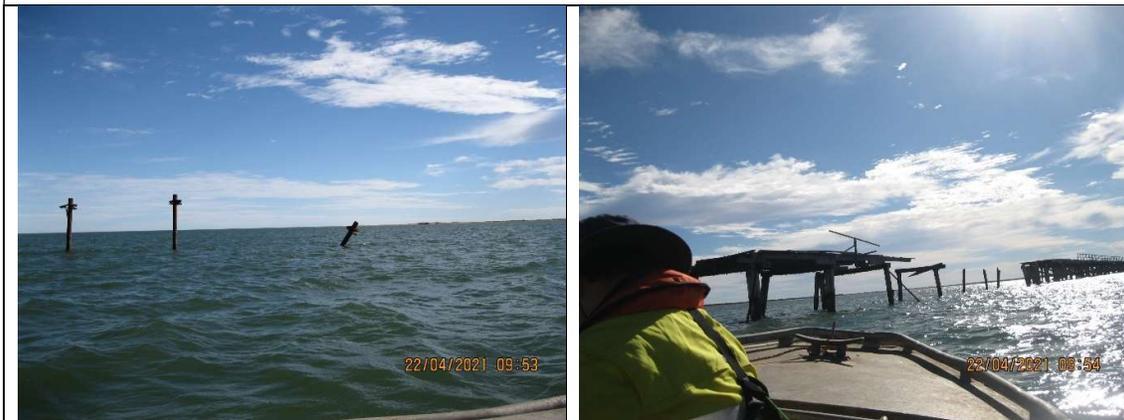
It is likely that there are stumps of broken timber piles located at or just above seabed which could pose a danger to boating.

Photo 8: Jetty Approach between Piers 186 and 218

Photo 9: Jetty Approach - Pier 186 is the end of the complete section

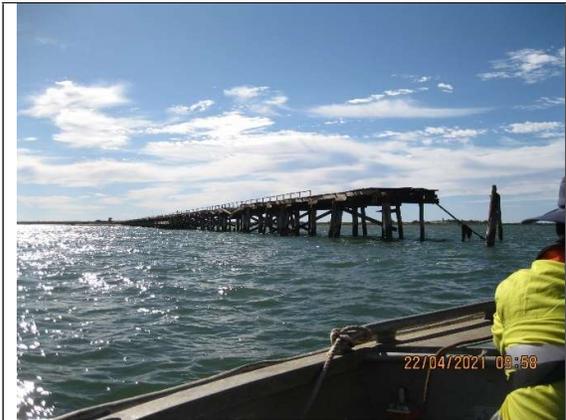
Photo 10: Approach jetty Shallow area - Piers 70 to 186

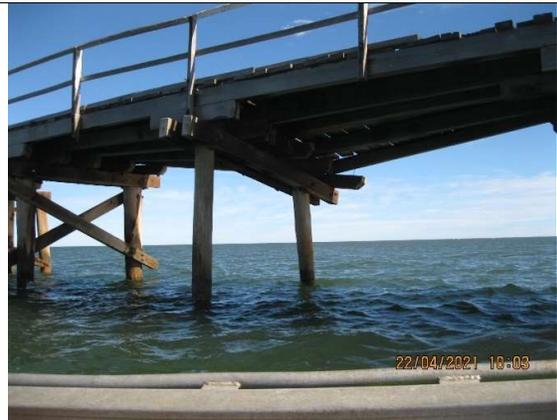
Photo 11: Broken pile causing jetty to collapse

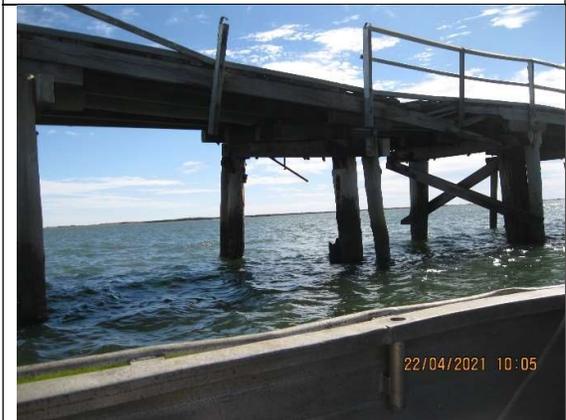
Photo 12: Broken Stringer and missing braces

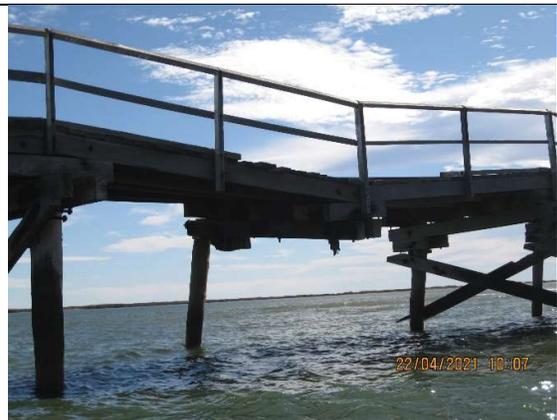
Photo 13: Missing pile and cross braces

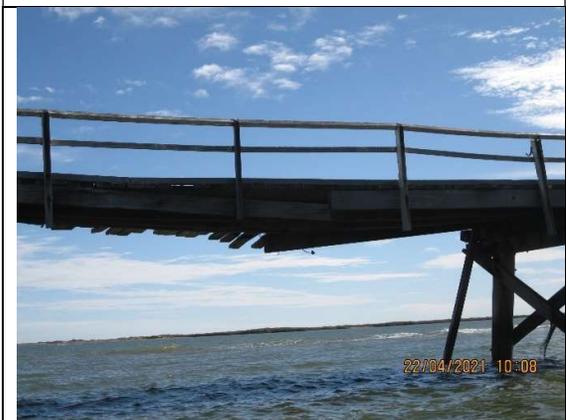
Photo 14: Missing Pier

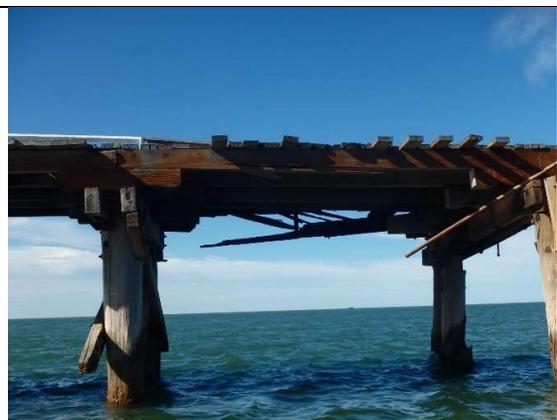
Photo 15: Broken Stringer and missing handrail

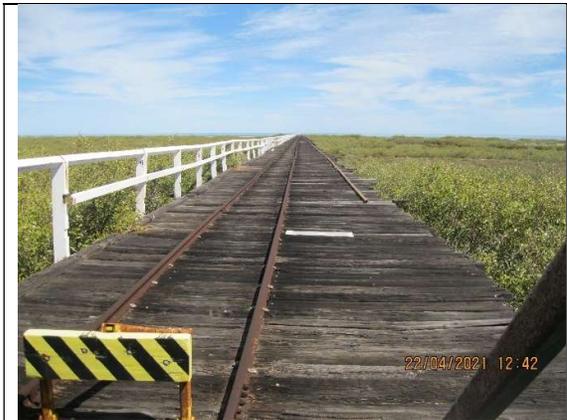
As previously mentioned, this section of the jetty is within the mangrove wetland which is only inundated during higher tides. The mangroves prevent wave action from impacting the structure even during periods of high tide and storm surges. Deterioration in this section is due to age, termite attack and a high likelihood of marine borers near the mud line – Refer Photo 16 to Photo 23.

Photo 16: View of approach jetty from abutment to end of mangroves - no storm damage evident

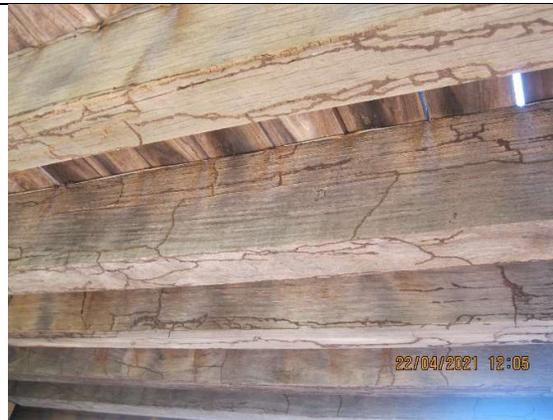
Photo 17: Evidence of termite on stringers near abutment

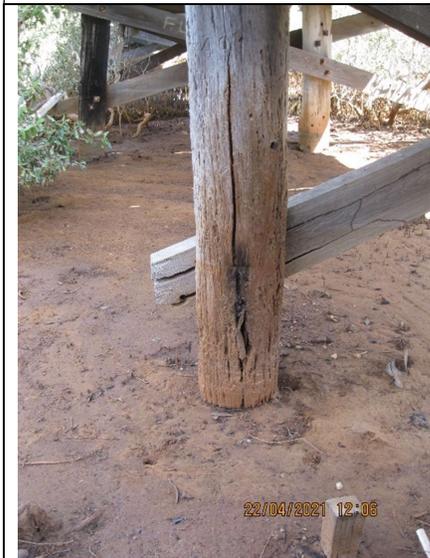
Photo 18; Pile near abutment showing evidence of rot. Likelihood of necking below the mudline when mud level was lower.

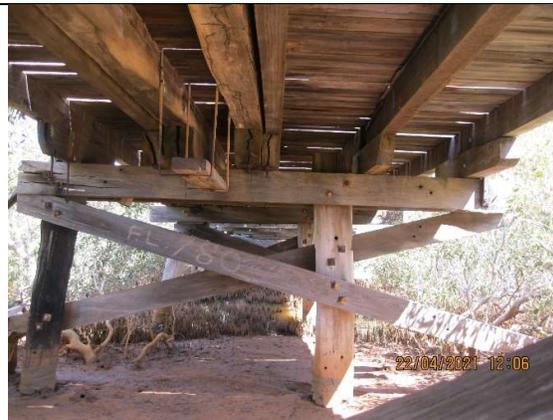
Photo 19: Abutment pile showing evidence of previous fire. Note also split corbel which is prevalent throughout.

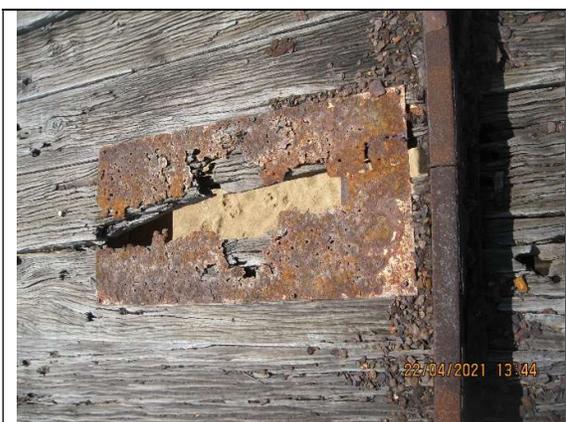
Generally, the decking planks are well weathered and require replacement. Some boards have been replaced over the years. Refer Photo 20 to Photo 23

Photo 20: Typical condition of deck planks

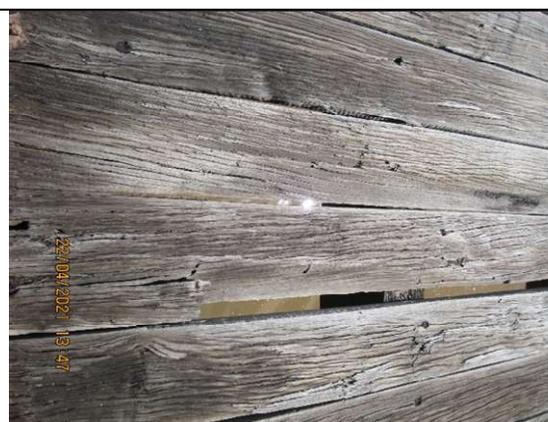
Photo 21: Split and worn deck planks

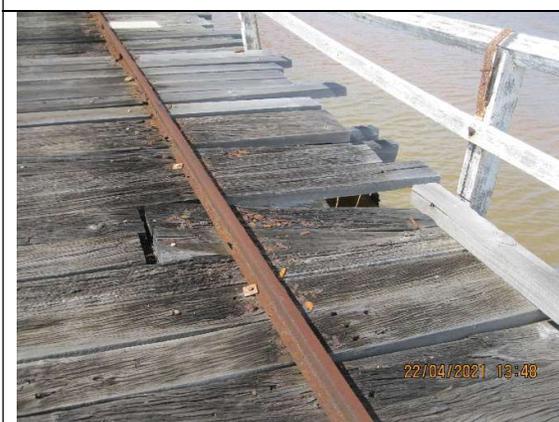
Photo 22: Unsafe deck planks - replaced deck planks can be seen in the background

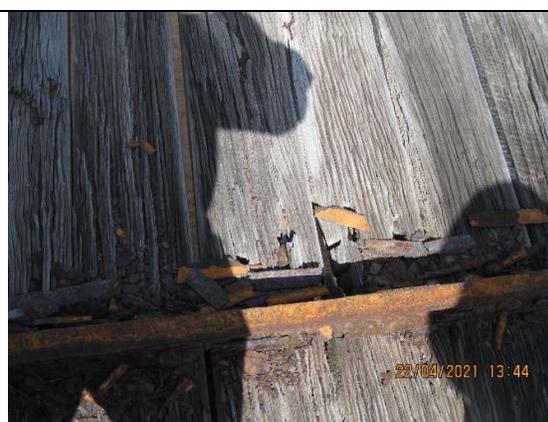
Photo 23: General deterioration of decking and rail line

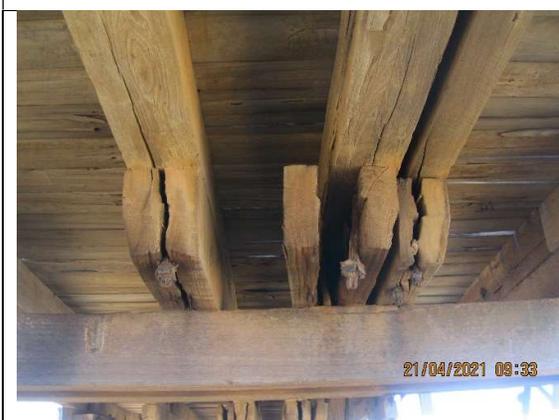
Photo 24: Typical detail of split corbels resulting in separation of corbels and stringers from the crossheads

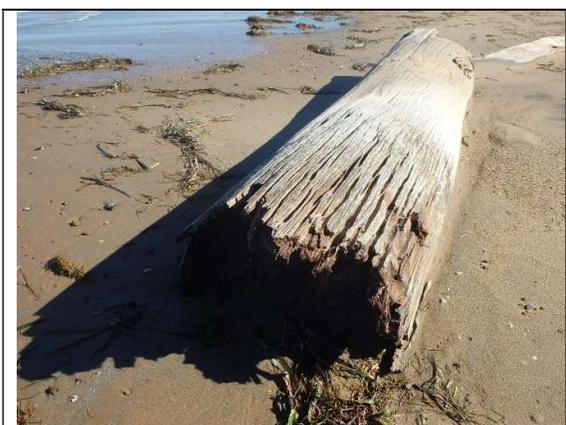
Salvaged timber members shown in Photo 25 to Photo 30 were inspected to ascertain weaknesses and likely modes of failure. Salvaged piles consistently showed evidence of Limnoria attack at the waterline with resultant rot inside the pile. Piles were snapped at this location. It is likely that many existing piles are similarly affected. There was little evidence of Teredo infestation in salvaged piles.

Photo 25: Typical pile showing break at waterline due to rot and Linnoria attack.

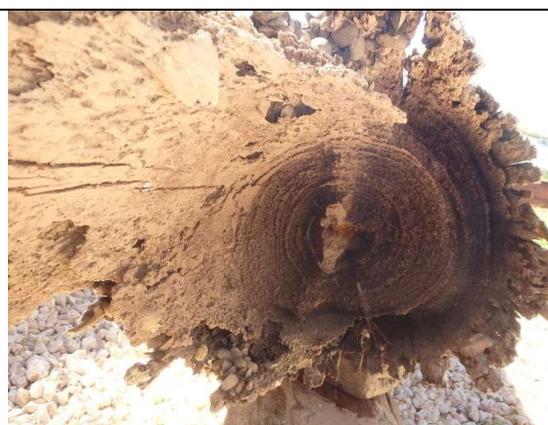
Photo 26: View inside snapped pile

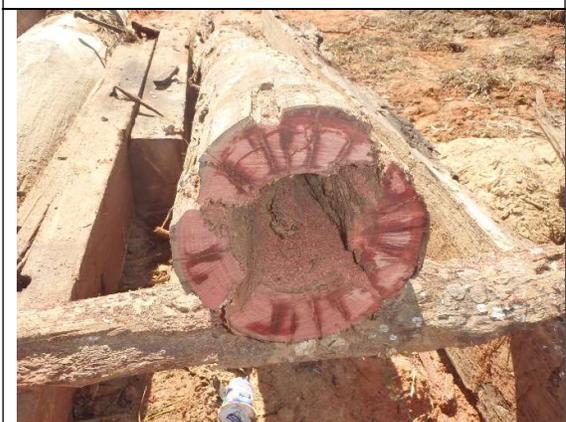
Photo 27: Salvaged pile cut just above necked area where pile snapped showing internal rot

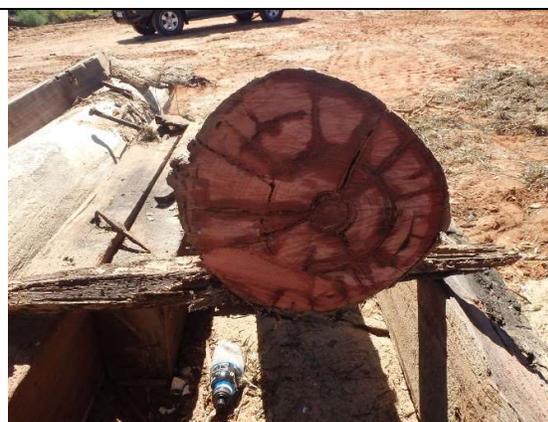
Photo 28: Further section above rot area confirming that Teredo not present

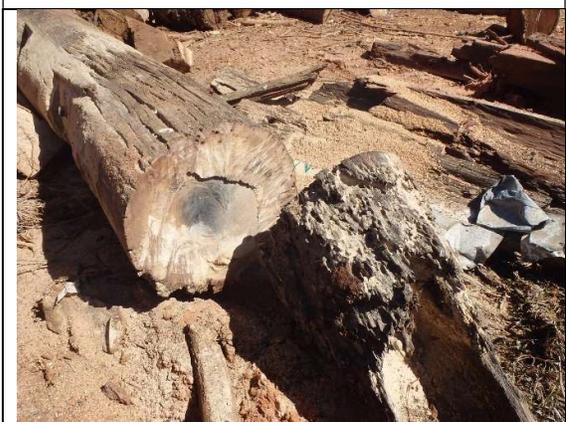
Photo 29: Salvaged pile cut just above necked area (MSL) – no evidence of Teredo

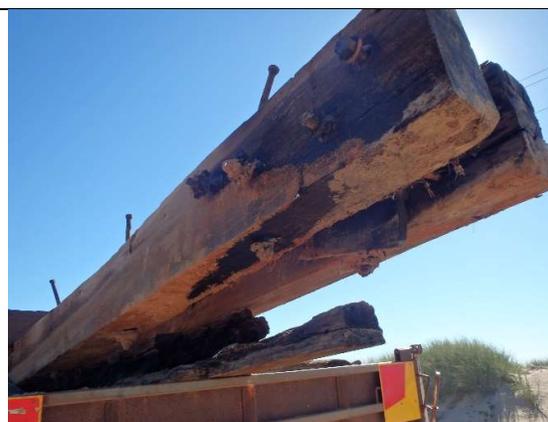
Salvaged Crossheads showed that corbels were broken away by a combination of split corbels leaving the bolts in place as well as failed bolts due to corrosion.

Photo 30: Salvaged Crosshead showing bolts in place where corbels were secured

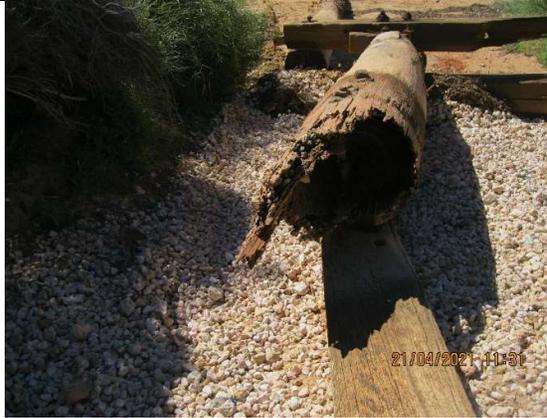
*Photo 31: Salvaged timber piles still attached to broken crossheads. Pile at top of photo has rotated. Both piles snapped at mid tide level due to rot and attack by marine organisms - predominantly Limnoria.*

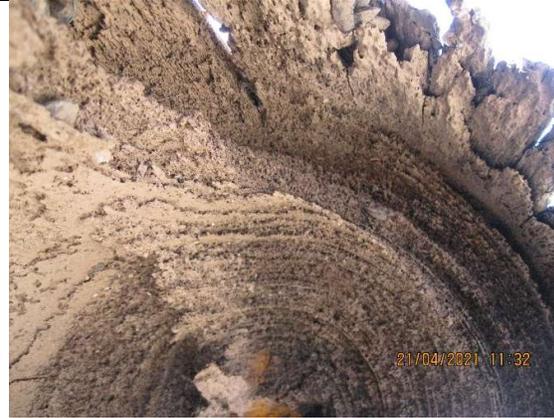
*Photo 32: End view of pile at top of photo (Photo 31)*

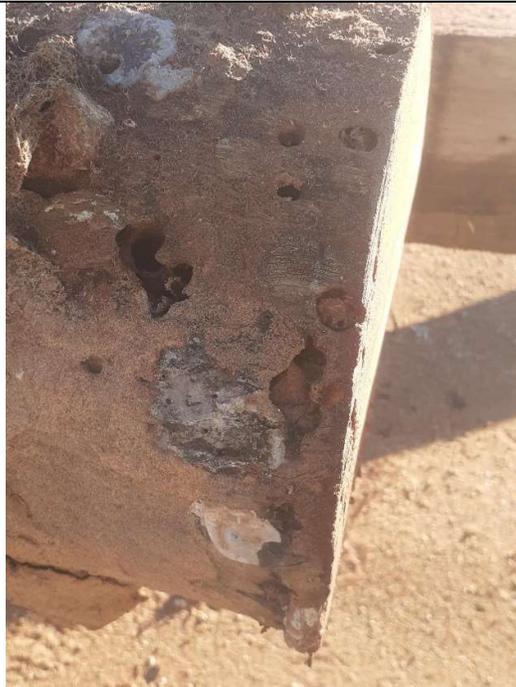
*Photo 33: Same Pile with rotted section cut off to determine extent of Teredo Infestation.*

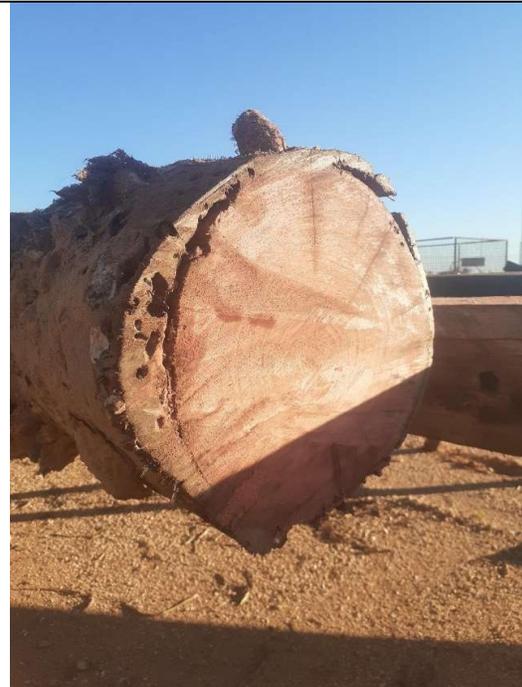
*Photo 34: End view showing minimal Teredo activity.*

While the above photos show minimal Teredo damage it is likely that teredo would have been more active closer to the mud line.
