Carnarvon One Mile Jetty

DE-CONSTRUCTION METHODOLOGY

H+H ARCHITECTS
AUGUST 2021

H+H Architects have been engaged by Dept of Transport for the de-construction of the Carnarvon One Mile Jetty following catastrophic damage caused by Cyclone Seroja in April 2021.

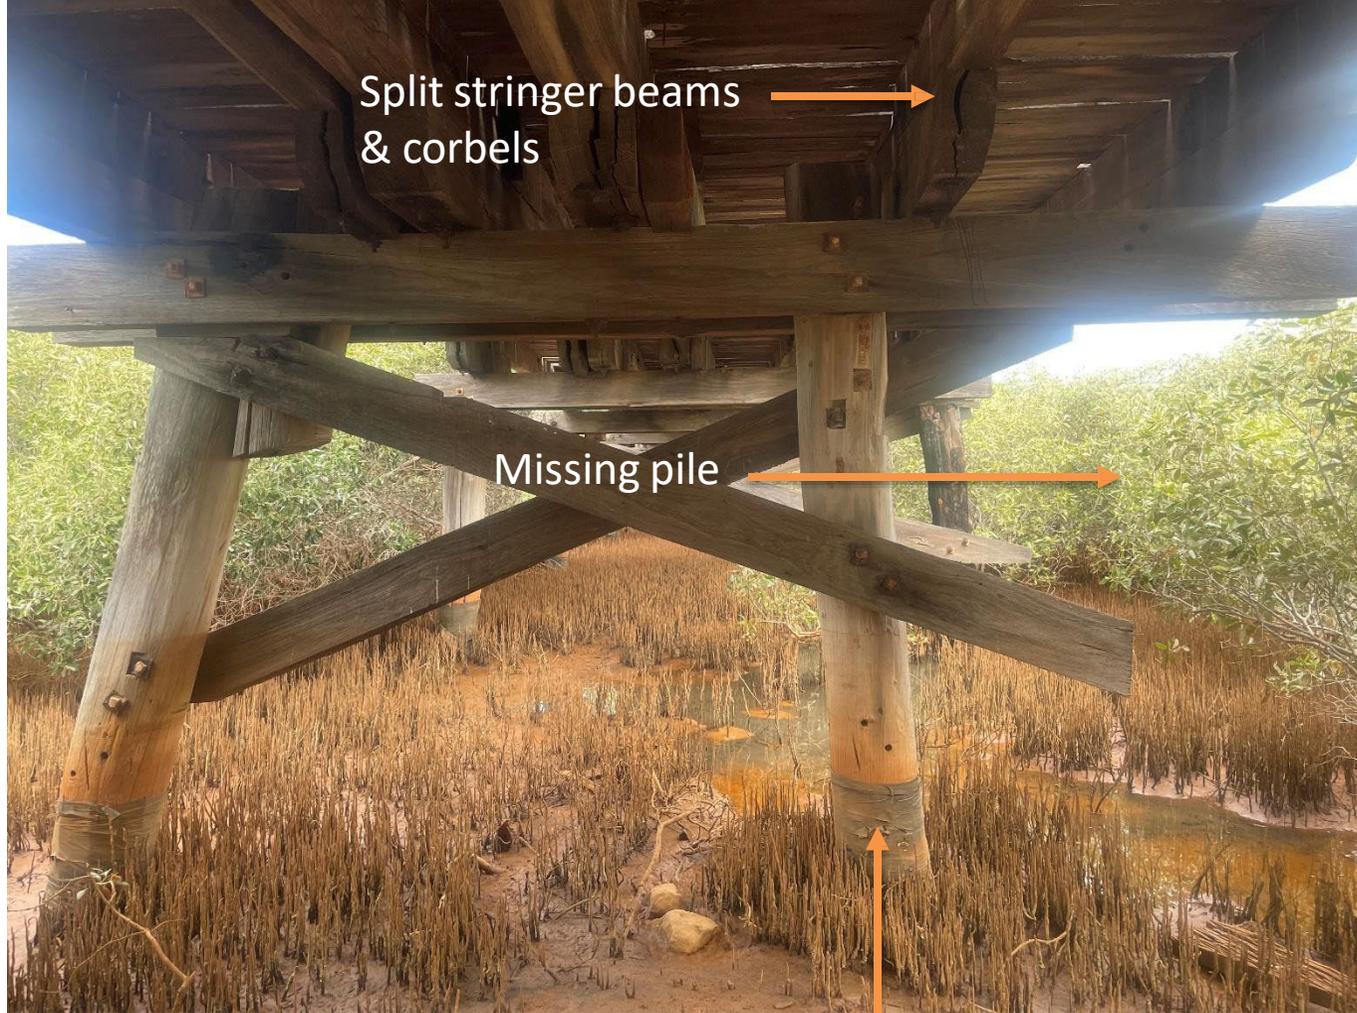
Split stringer beams
& corbels

Missing pile

Inadequate wrapping

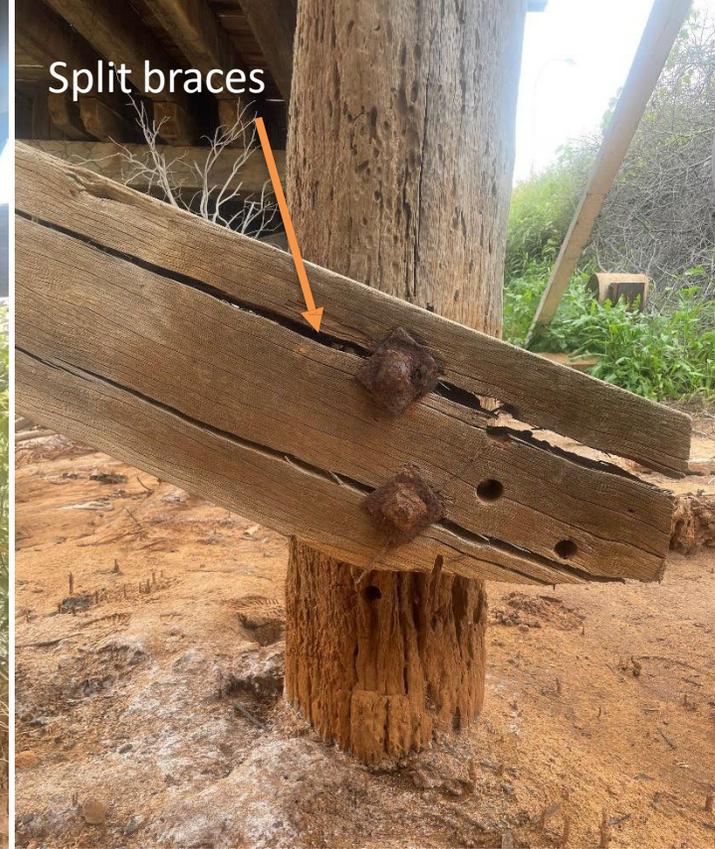
Split braces

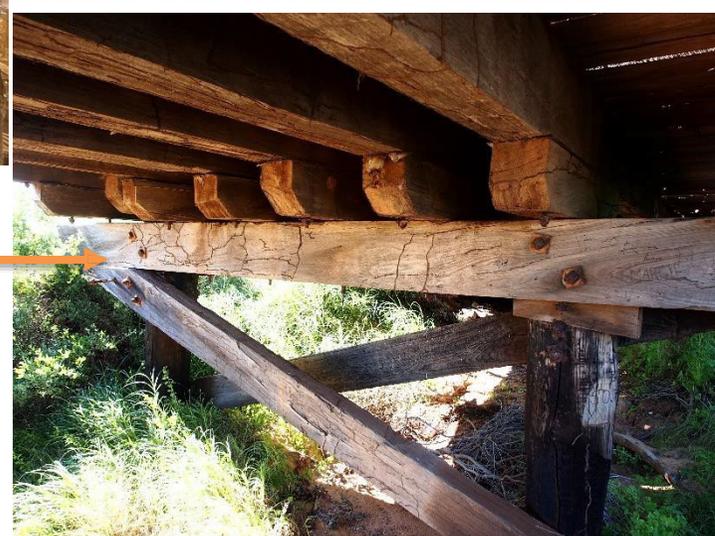
Termite damage

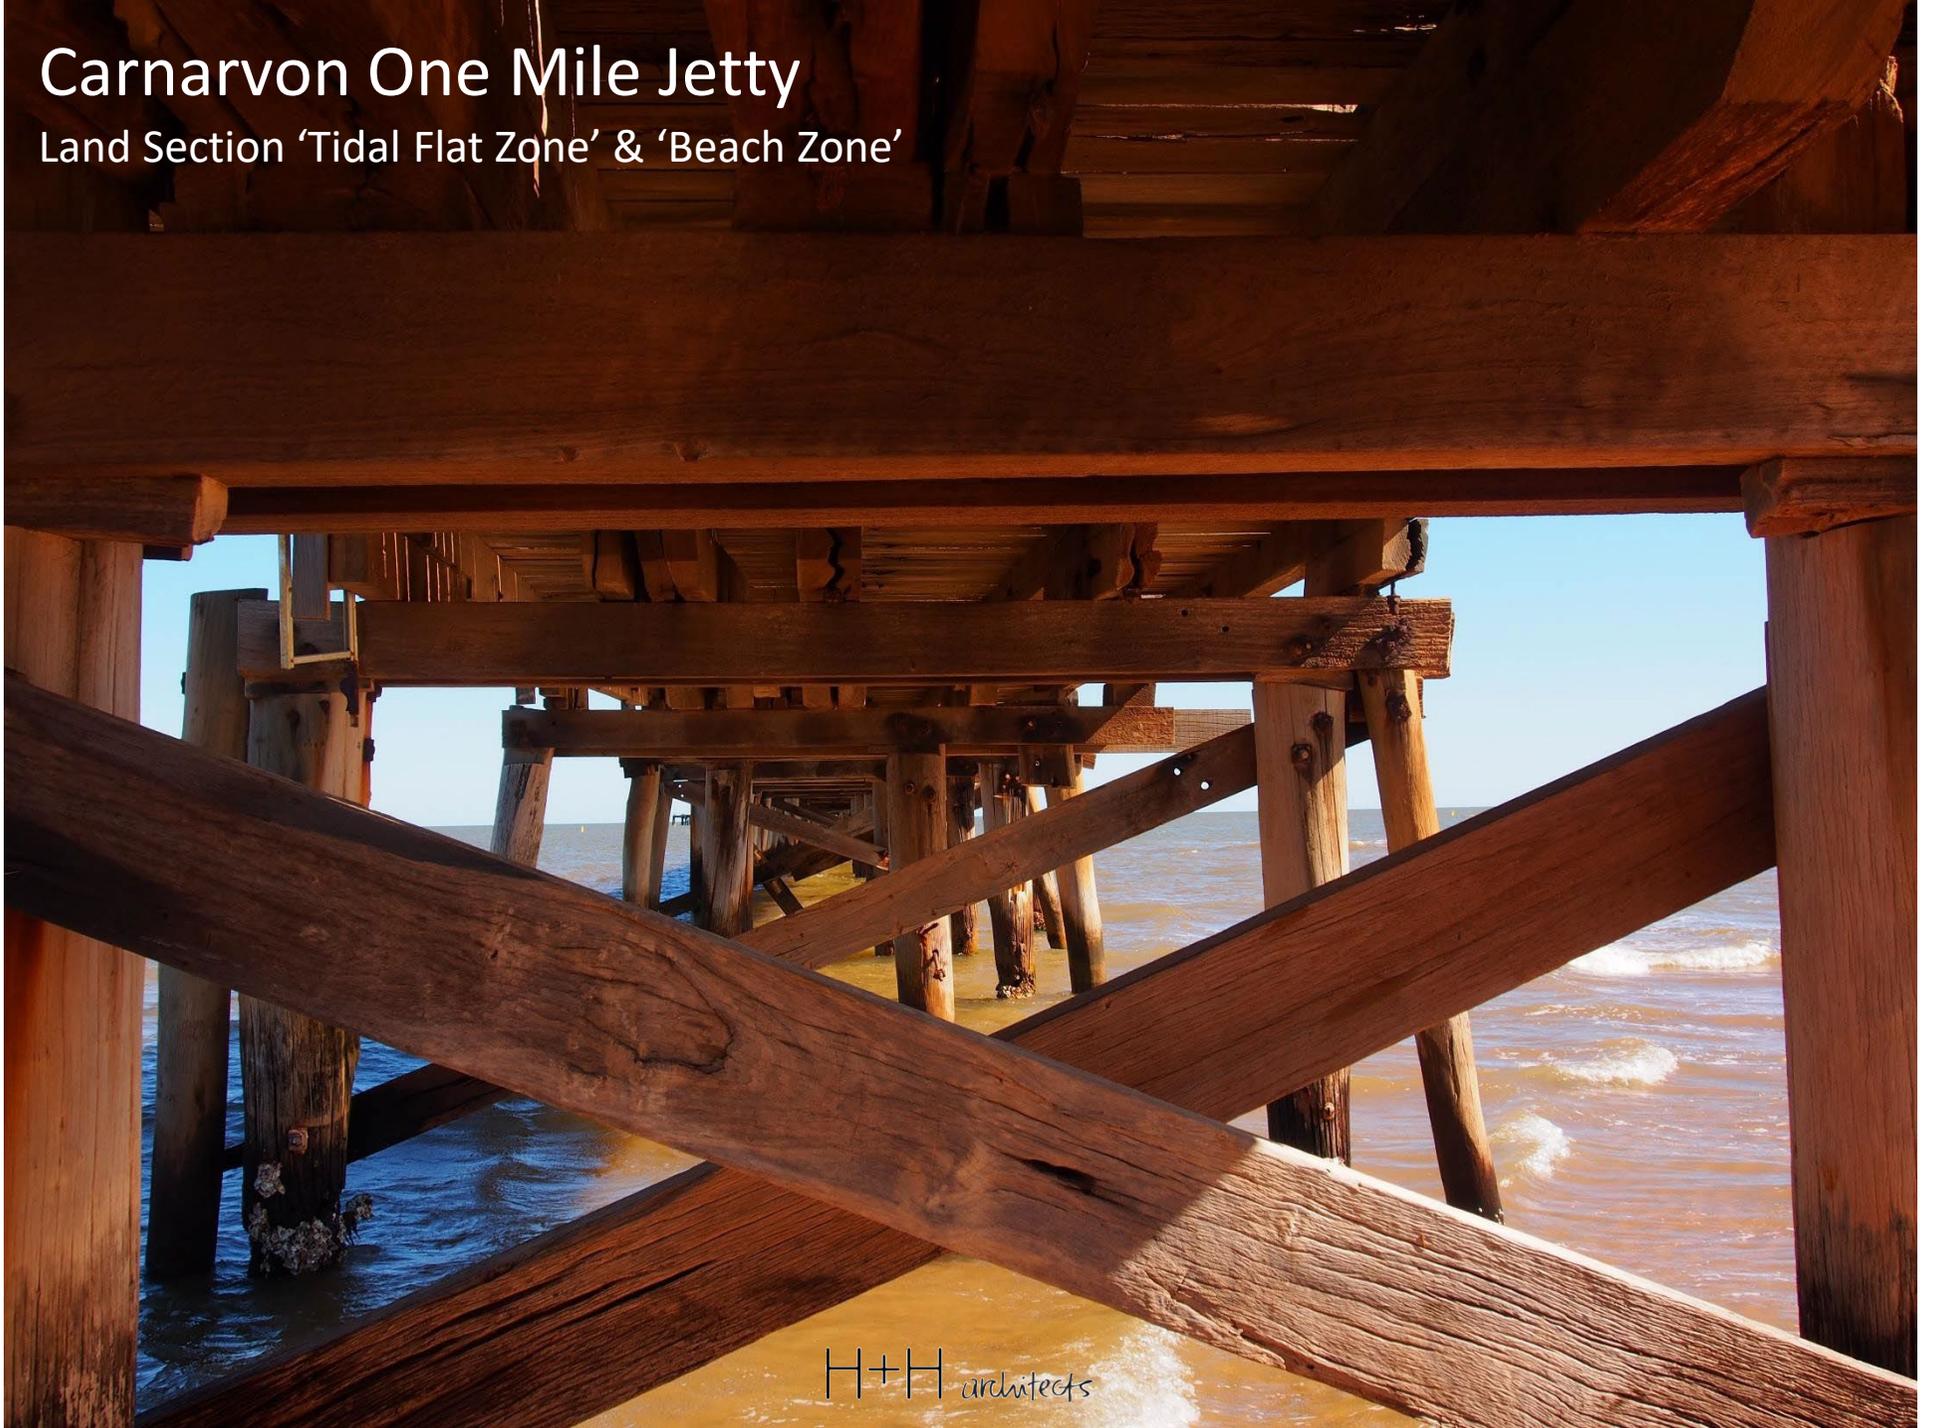
Rotated stringers & corbels

Failed jetty bent

Hollow piles
