**Carnarvon One Mile Jetty  
Damage Assessment Post Cyclone Seroja  
21<sup>st</sup> & 22<sup>nd</sup> April 2021**

**Department of Transport**

Report 2021/0401

28<sup>th</sup> April 2021

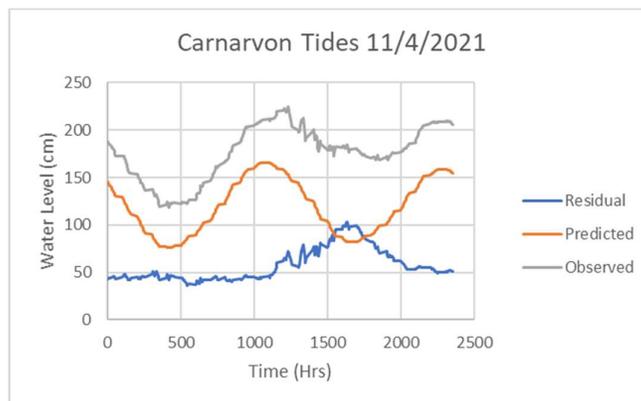
Figure 2: Carnarvon tides on the day of Cyclone Seroja

Predicted astronomical tides for Sunday 11<sup>th</sup> April were high tide – 1.66m at 1040 Hrs and low tide 0.82 at 1648 Hrs. The maximum tidal residual (storm surge) measured at the Department of Transport tide gauge was 1.03m at 1635 Hrs, fortunately this coincided with the low tide. The maximum observed water level was 2.25m at 1230 Hrs. A plot of the observed and predicted tides as well as the residual (storm surge) is shown in Figure 2.

The section of the approach jetty between Piers 186 and 218 (approximately 190m) was effectively totally destroyed with only two small sections left standing see Photo 8 and Photo 9. This section of jetty is in an average depth of RL -2m CD. Given the tide and storm surge at the time (Refer Figure 2), the total still water level (SWL) would have been in the order of 4 to 4.5m CD in this location and therefore capable of sustaining a wave of up to 4m in height. The crest height of a breaking wave in this location could be as high as 5.4m (SWL +80% wave height). Photo 6 and Photo 7 taken by Eddie Smith (Carnarvon Shire) show waves breaking over the jetty at this location.
