Carnarvon One Mile Jetty

DE-CONSTRUCTION METHODOLOGY

H+H ARCHITECTS
AUGUST 2021

H+H Architects have been engaged by Dept of Transport for the de-construction of the Carnarvon One Mile Jetty following catastrophic damage caused by Cyclone Seroja in April 2021.

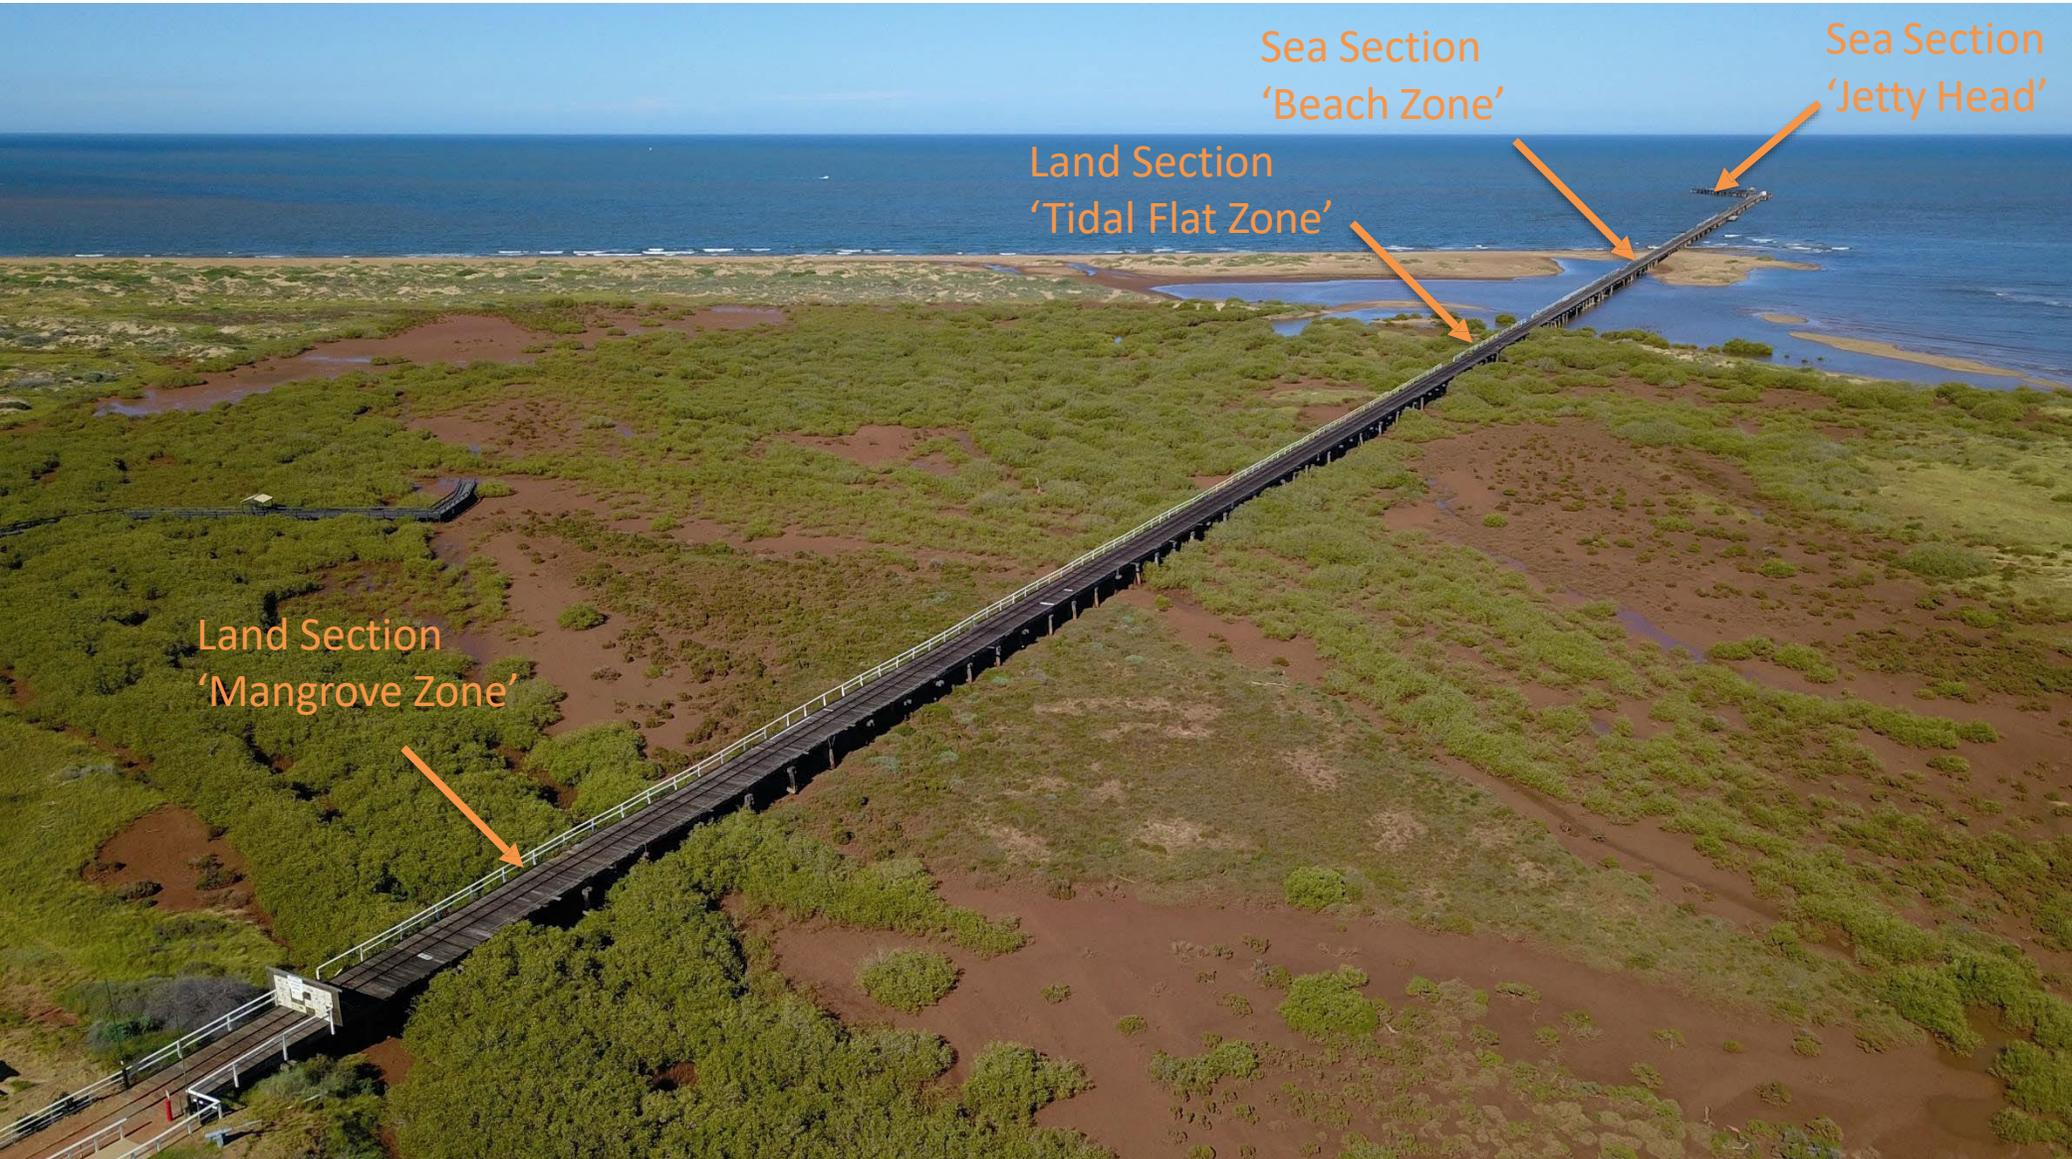
Carnarvon One Mile Jetty – just prior to Cyclone Seroja

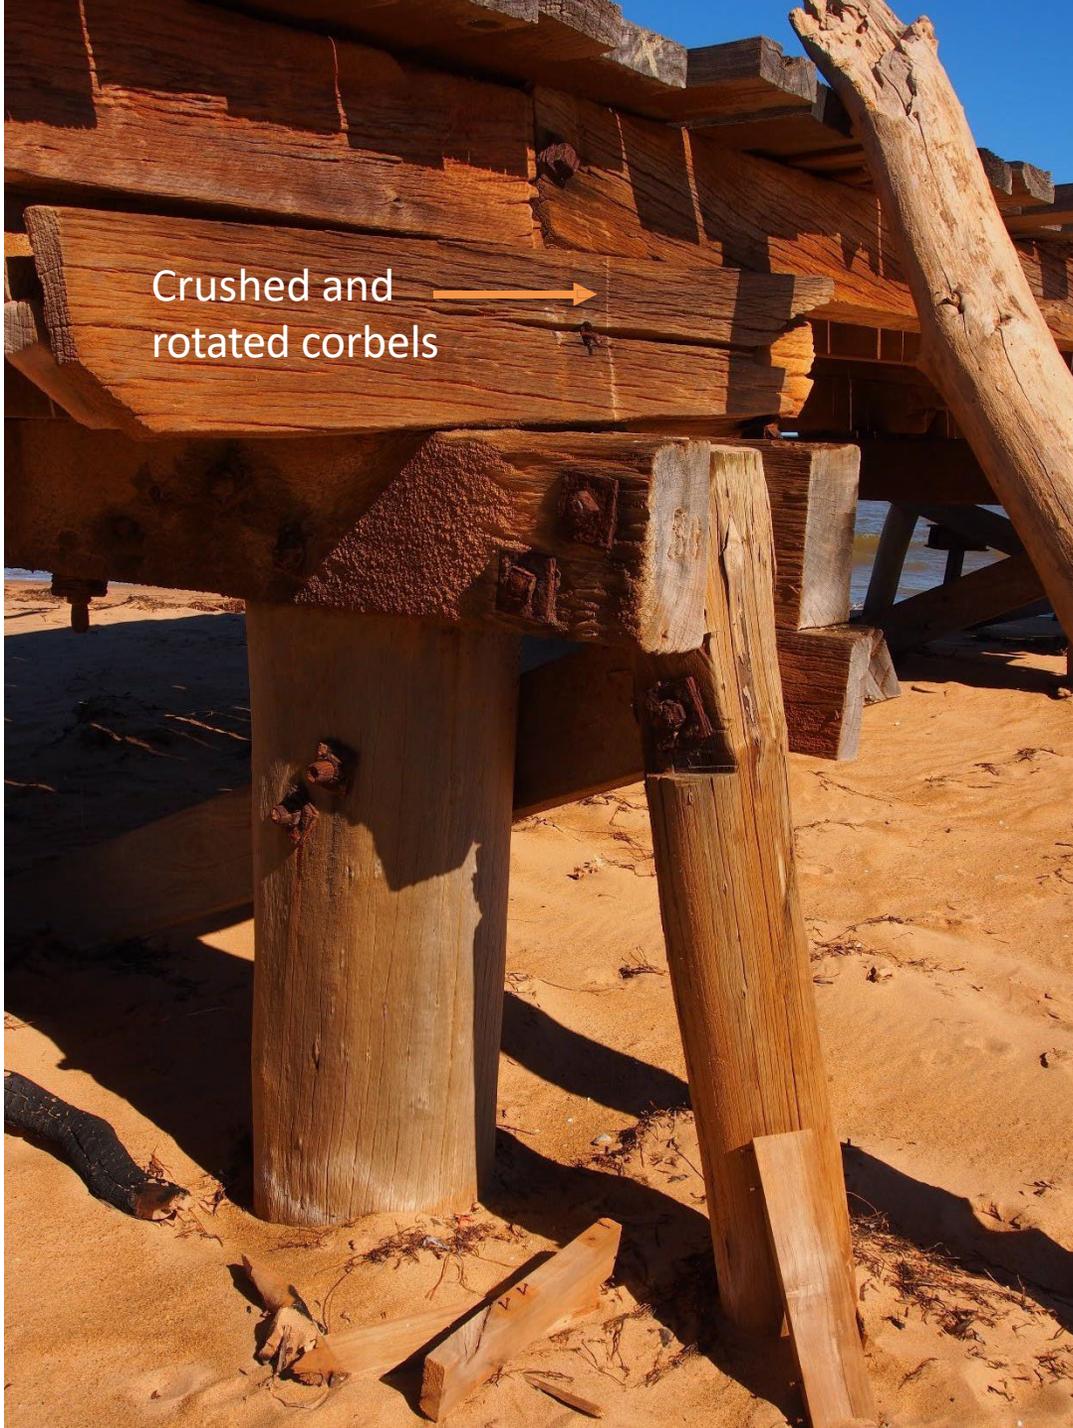
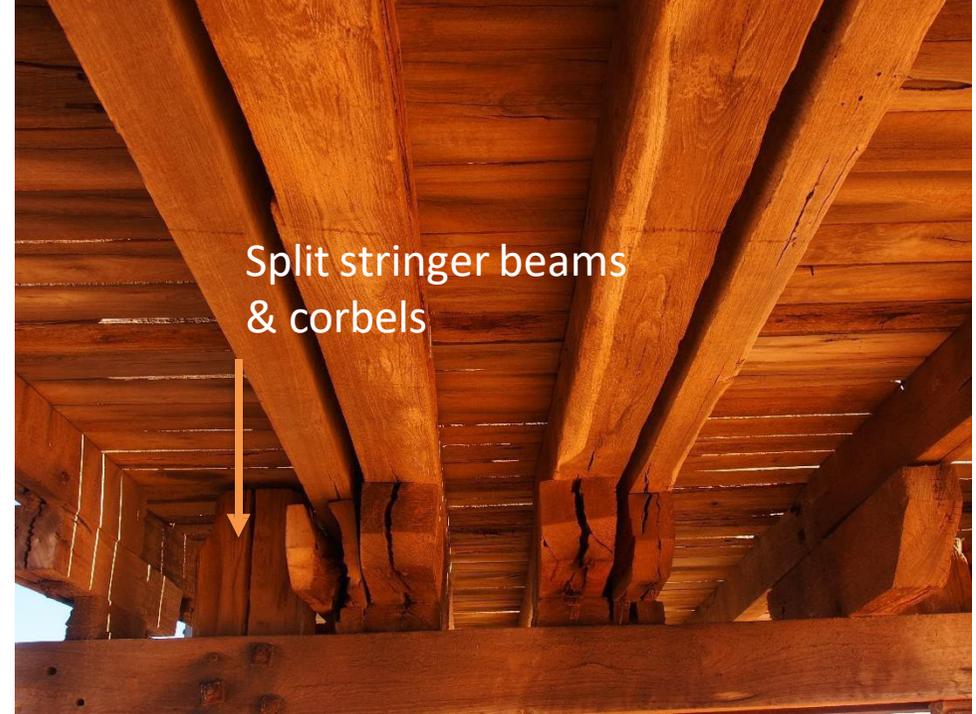
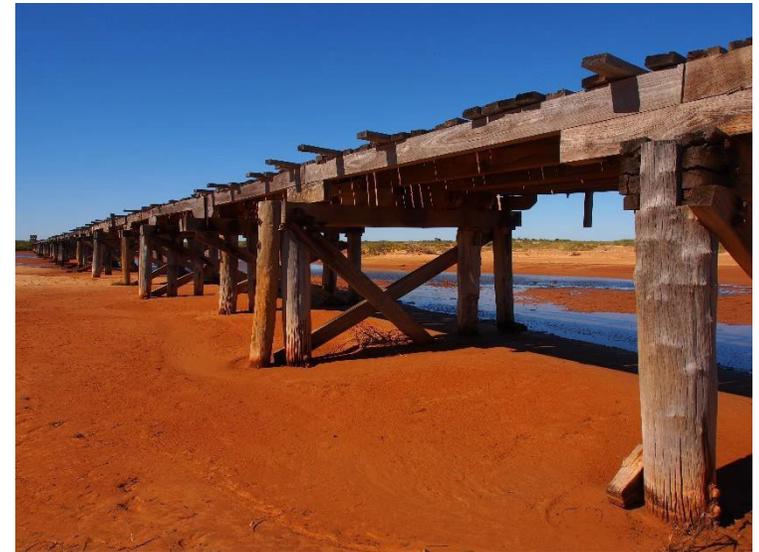
Carnarvon One Mile Jetty
Land Section 'Tidal Flat Zone' & 'Beach Zone'

Rotated stringers & corbels

Failed jetty bent

Hollow piles

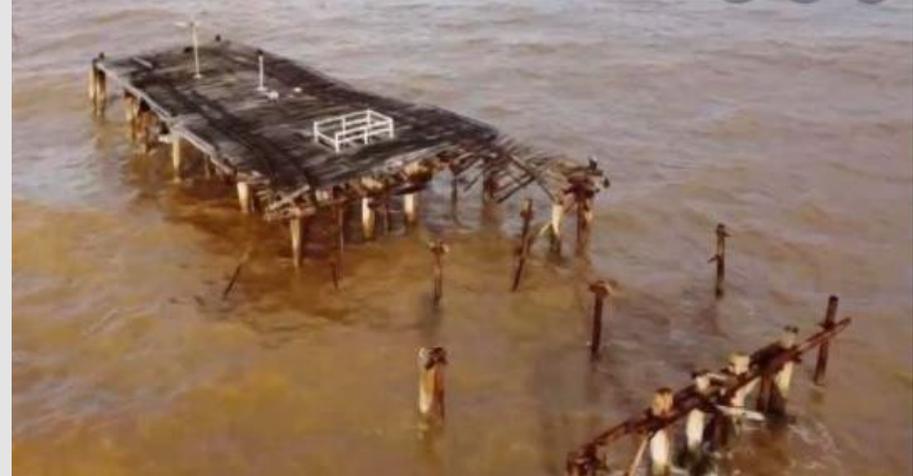
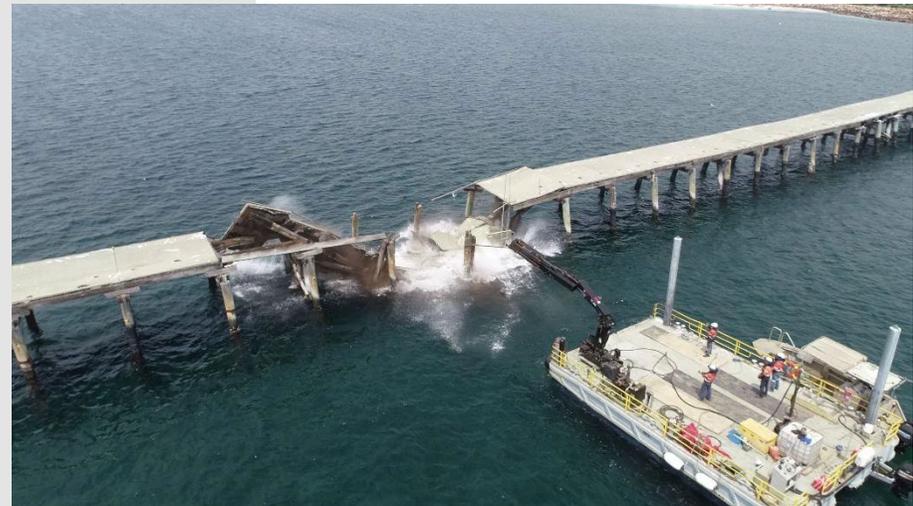
Sea Section

- Extremely high risk of collapse due to unsupported members
- Piers 186-225 have already been completely or mostly lost in the Cyclone
- Piers 100-186 substantially damaged but retain some jetty bents and elements
- Hydraulic claw and crane used to lift heavy timber sections onto barge
- It may be difficult to determine in advance which pile is loadbearing. Priority to be placed on safe removal of the original piles.
